LANDSLIDES AND RELATED FEATURES

OF THE BELLEVILLE, TENN. QUADRANGLE

by
ROGER E. THOMAS
1982

U.S. Geological Survey
Open File Map 82-750 (C-12)

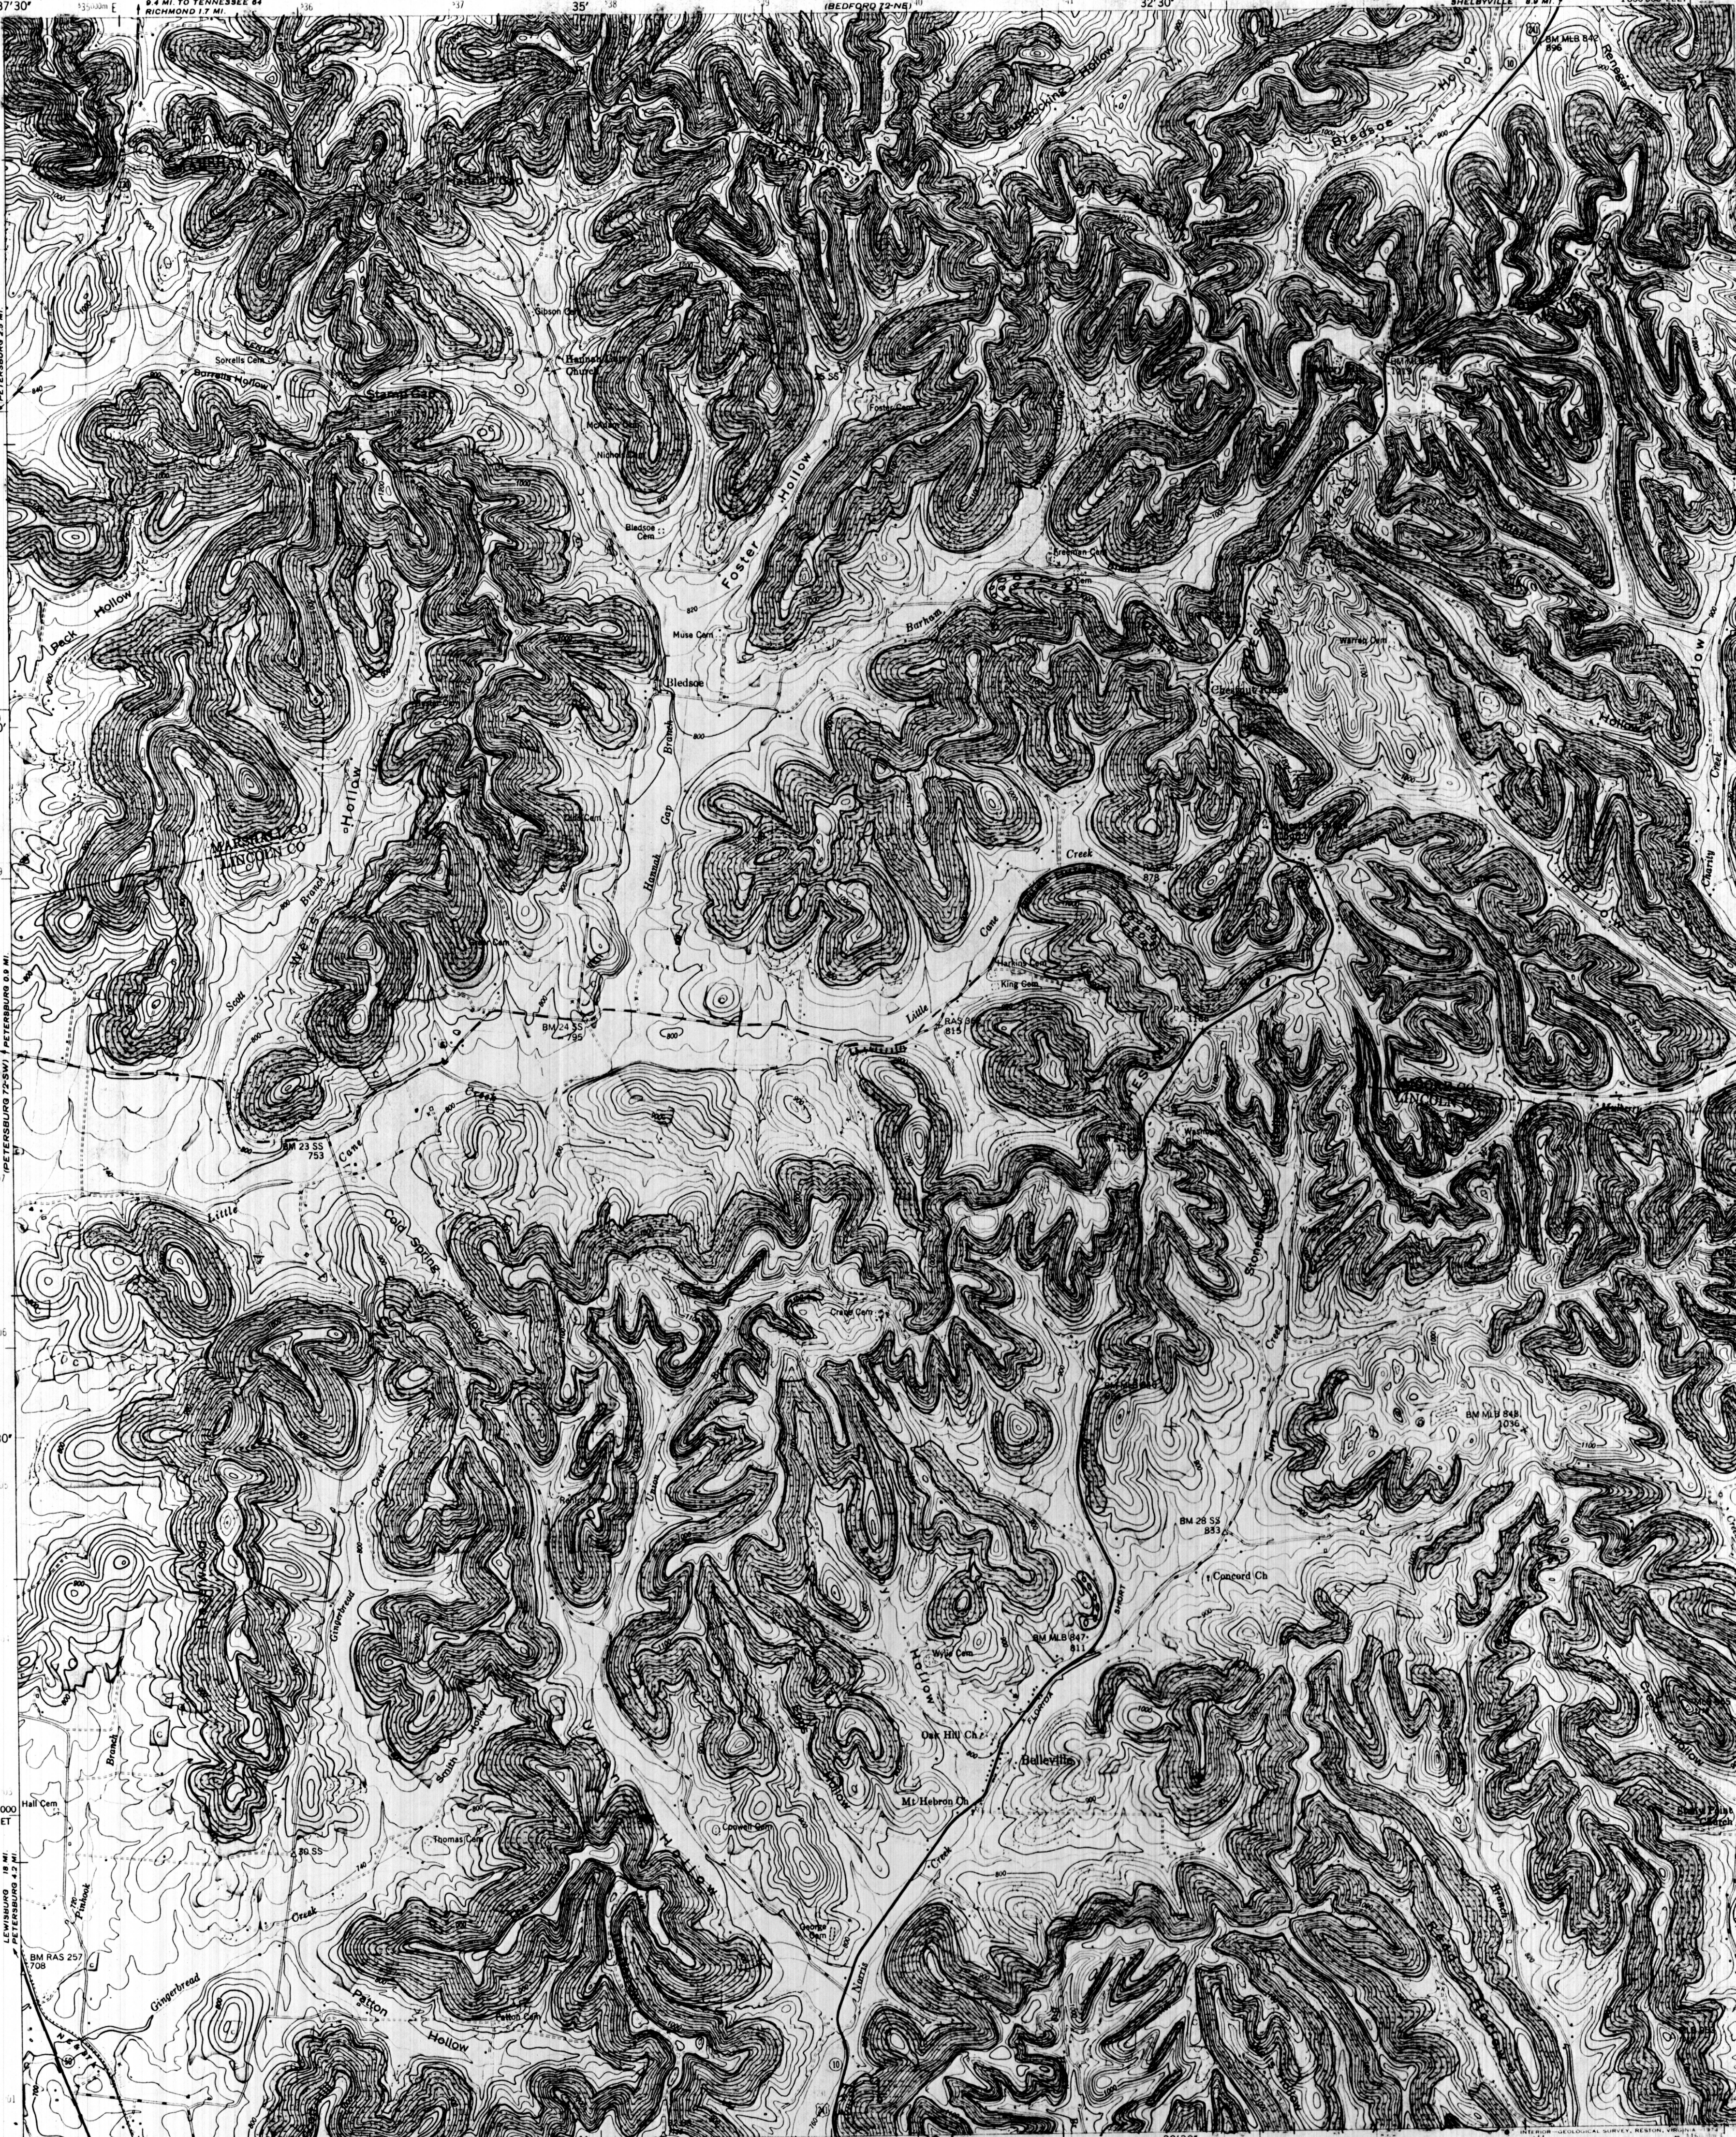
Landslides and related features interpreted
from aerial photographs:
1:40,000 (black and white) 1976
1:40,000 (black and white) 1979
Photointerpretation and field check 1980-1981
This report is preliminary and has not
been reviewed for conformity with U.S.
Geological Survey editorial standards.

- ACTIVE OR RECENTLY ACTIVE LANDSLIDE**
Complex landslide composed of earthflow, debris
slide, earth and rock slump. Identified from
historical records, and from scars, debris and
other field evidence. Ground extremely unstable;
sliding accelerated by excavation, loading and
changes in drainage conditions. May include
areas with several active slides too small to
be shown separately. Questioned where doubtful.

- OLD LANDSLIDE**
Area of extensive hummocky ground caused by
earthflow and earth and rock slump. Lacks
clear evidence of active sliding. Relatively
stable in natural, undisturbed state,
generally not affected by small structures properly
sited in areas away from the edge of the toe;
can be reactivated by extensive, rapid exca-
vation, loading, and changes in ground water and
surface water conditions. Area of old landslide
probably includes recent ones not identified
from field evidence or otherwise documented.
Upslope boundary of landslide generally defined
by modified scarp, but downslope (toe) may be
gradational and not well defined. Questioned
where doubtful.

- COMBINATION LANDSLIDE**
Area of recent and old slides in which
individual slides are not identified.
- COLLUVIAL SLOPE**
Valley wall along major streams with slope as
steep as 40° (85%); stony, clayey silt soil up
to 50 ft. (15 m) thick; commonly buttressed by
a terrace or bench at the toe of the slope; very
susceptible to sliding by cutting of toe area,
removal of terrace or bench, and overloading;
slide commonly activated without apparent cause.

- COLLUVIAL SLOPES WITH LANDSLIDES**
Landslides too small or obscure to map
individually.
- AREAS SUSCEPTIBLE TO DEBRIS FLOWS AND DEBRIS
AVALANCHES**
Primarily shallow, narrow ravines and chutes with
accumulation of stony colluvium generally 10 ft.
(3 m) or less in thickness; susceptible to rapid
movement during intense rainfall. Most ravines
and chutes designated show evidence of former
debris flows and avalanches.

- AREAS SUSCEPTIBLE TO ROCKFALL**
Steep, locally vertical, natural and man-made
slopes and cliffs, 15 ft. (4.5 m) or more high;
formed dominantly of sandstone, limestone, sandy
shale, mudstone and claystone. Interbedded mud-
stone, claystone and shale weather rapidly leaving
sandstone and limestone rock faces unsupported.

- SOIL AND ROCK SUSCEPTIBLE TO LANDSLIDING**
Soil and rock similar to that involved in land-
slides elsewhere in map area; primarily areas
underlain by claystone, mudstone and shale
associated with other rock types. Rock weathers
rapidly on exposure forming clayey soil highly
susceptible to sliding. Includes coves (U-shaped,
shallow valleys) containing thick layers of clayey
soil that are very susceptible to sliding where
excavation breaks continuity of slope and where
overloaded by artificial fill.

AREAS LEAST PRONE TO LANDSLIDES
Map areas in which no patterns or symbols are shown;
primarily valley floors, ridge tops and broad
benches; modification by excavation and fill may
lead to local landslides.

- MAN-MADE FEATURES**
Strip mines (combination of letter symbols
indicates complex formed of more than one
type of strip mine)
- sh bench with high wall
sf furrowed with high wall
sd multiple furrows and multiple benches
ss hilltop removed
srg reclaimed by grading
sru reclaimed by secondary use
sh/r regraded in part, high wall
remains
- Coal refuse banks
r identified on aerial photographs;
not classified in field check
rb not burnt nor on fire
rbb burnt
rbd burning
rbs sludge
- Quarries
q quarry site
qub spoil bank, quarry waste
- Gravel pits
g site of gravel pit
- Slides in man-made features
af earth flow in fill

NOTE
Information shown is intended as a
general guide to ground conditions as of
the date of field check. Additional
landslides and rockfalls should be anticipated
in all map units. The map unit depicts
the dominant condition in the area delineated
and variations in slope stability may occur
at any point in the unit. This map is suit-
able for general planning purposes and as a
supplement to more detailed studies for site
selection. The map cannot be used as a sub-
stitute for detailed geologic and engineering
investigations to establish design and
construction criteria of specific sites.
Some symbols may not appear on this map
because the description is applicable to a
series of maps.

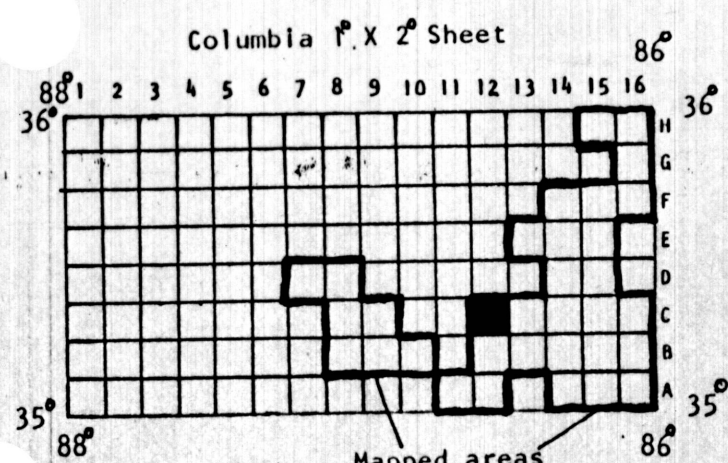
The first five digits of the open file number designate the
specific 1:250,000 scale map sheet of which this quadrangle
is a part. The last two digits designate the position of the
quadrangle in a subdivision of the 1:250,000 scale map based
on rows and tiers shown in the diagram to the right. The
location of this quadrangle is shown by the black square.
